# EFFECTS OF LONG TERM MOISTURE STORAGE ON CONCRETE TEST SAMPLES

By:  
Jeffrey Stein  
SRA International, Inc.  
Linwood, NJ  
USA

PRESENTED FOR THE  
2014 FAA WORLDWIDE AIRPORT TECHNOLOGY TRANSFER CONFERENCE  
Galloway, New Jersey, USA

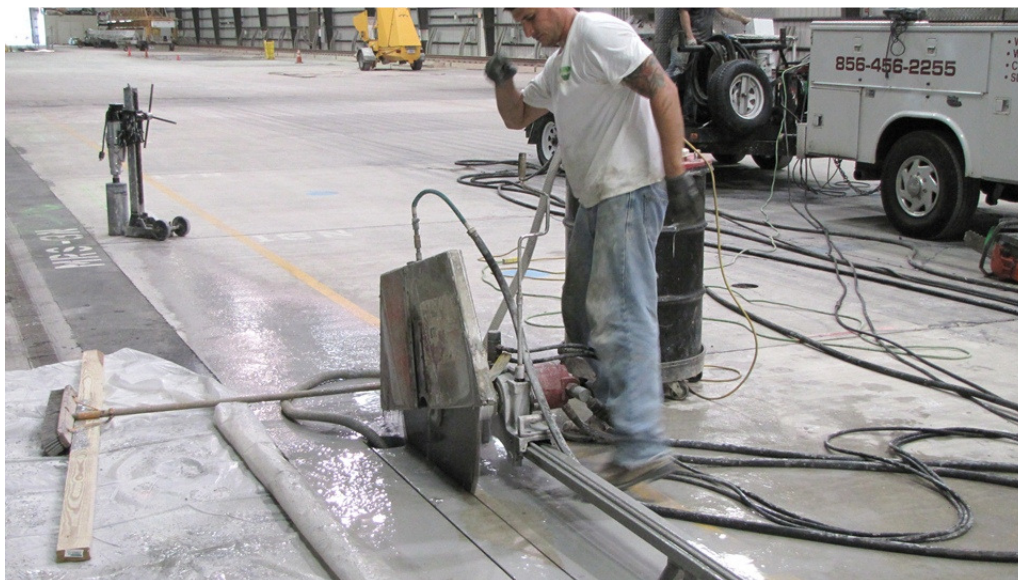
Figure 1. Track Saw Cutting Slab

A contractor was hired to cut beam samples from the CC6 test pavement after all traffic on the test sections was complete. The contractor cut three six-inch diameter cores from each slab and then used a diamond blade track saw to make two parallel cuts between the core holes. Anchor bolts were fitted to the two concrete samples from each slab. The pavement slice was removed using a chain-hoist and load frame. The pavement slice was rotated onto wooden supports. The track saw was repositioned to cut the pavement slice into  $6 \times 6$  inch beams taken from the middle of the concrete slice. Figures 1, 2 and 3 show concrete beams being cut and removed from CC6 pavement slabs.
